Patient Satisfaction of Esthetics with Resin Infiltration

Justin Hughes DDS and Dara Rosenberg DDS, MS, MPH
Department of Dentistry, St. Barnabas Hospital

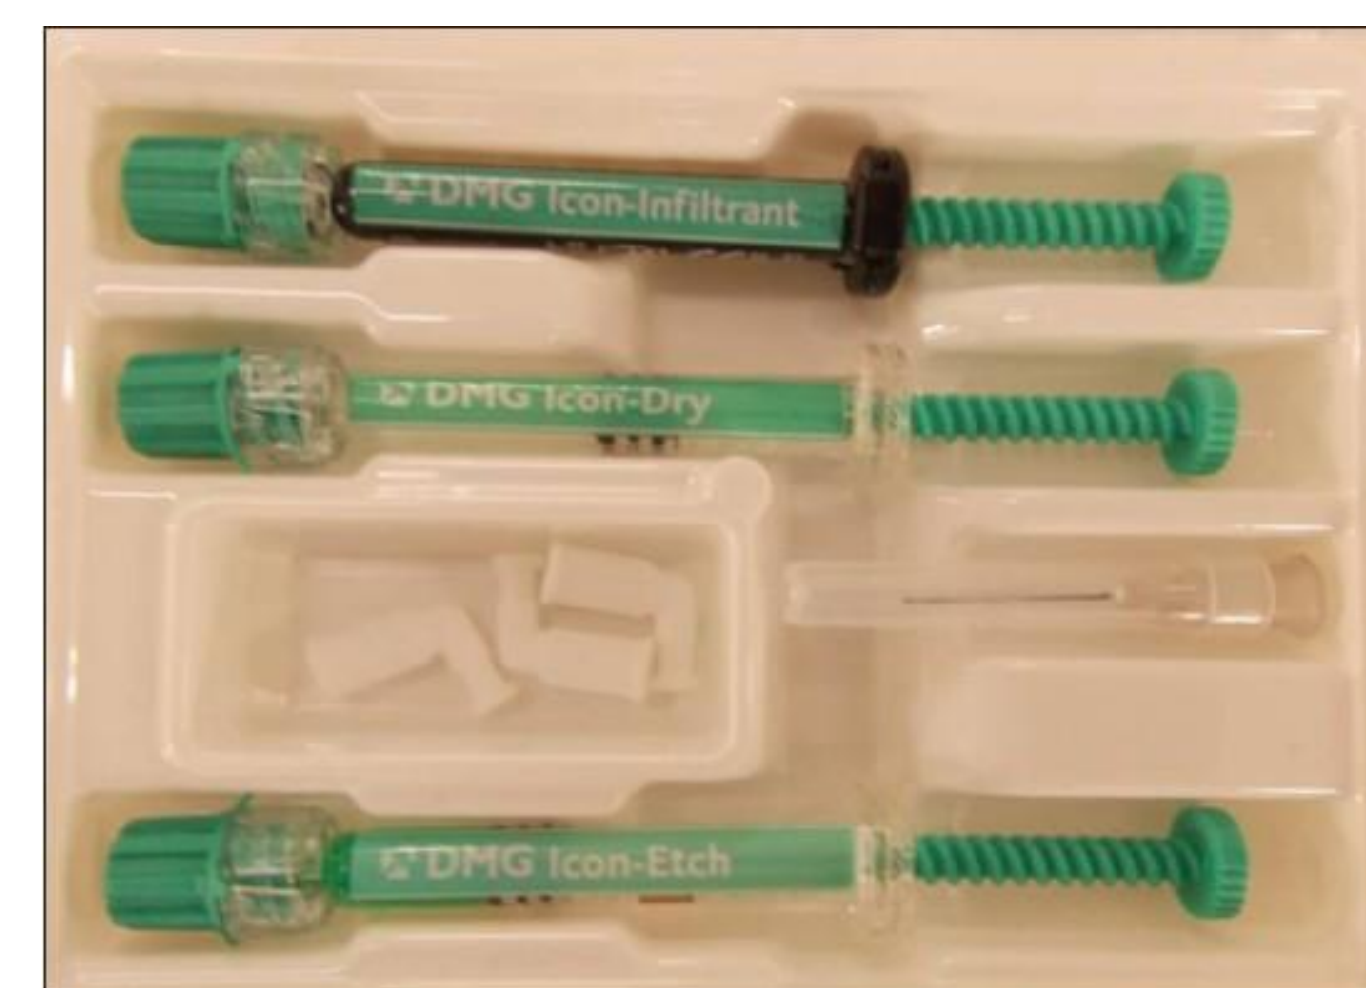
Figure A: Icon Resin Infiltration materials.

Supplies were provided by DMG America, the manufacturer of ICON. Treatment was rendered according to manufacturer instructions, and included the following: The teeth to be treated were isolated with a dental rubber dam and cleaned of natural biofilm. An acid etch (15% HCl gel) was applied to the teeth for 3 cycles of 2 minutes each, and then the teeth were desiccated with a solution of 99% ethanol. Following desiccation, the resin infiltrant was applied over a 3 minute period and cured with a dental curing light.

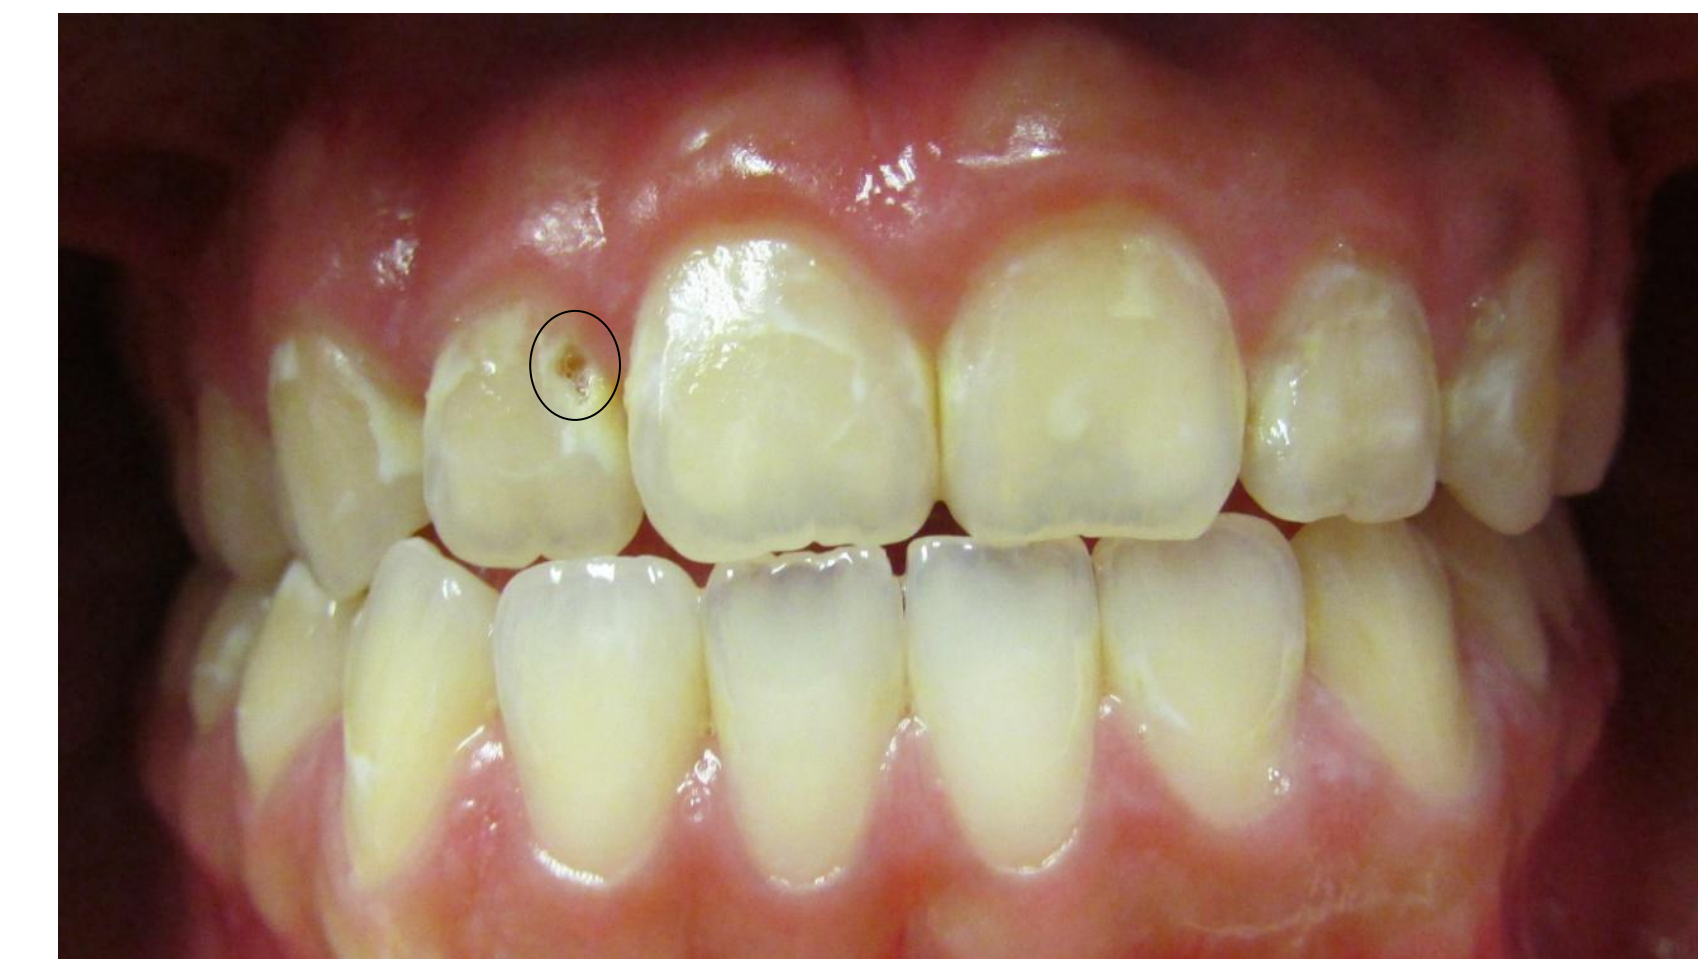
Figure B: Photograph showing maxillary anterior teeth before resin infiltration.

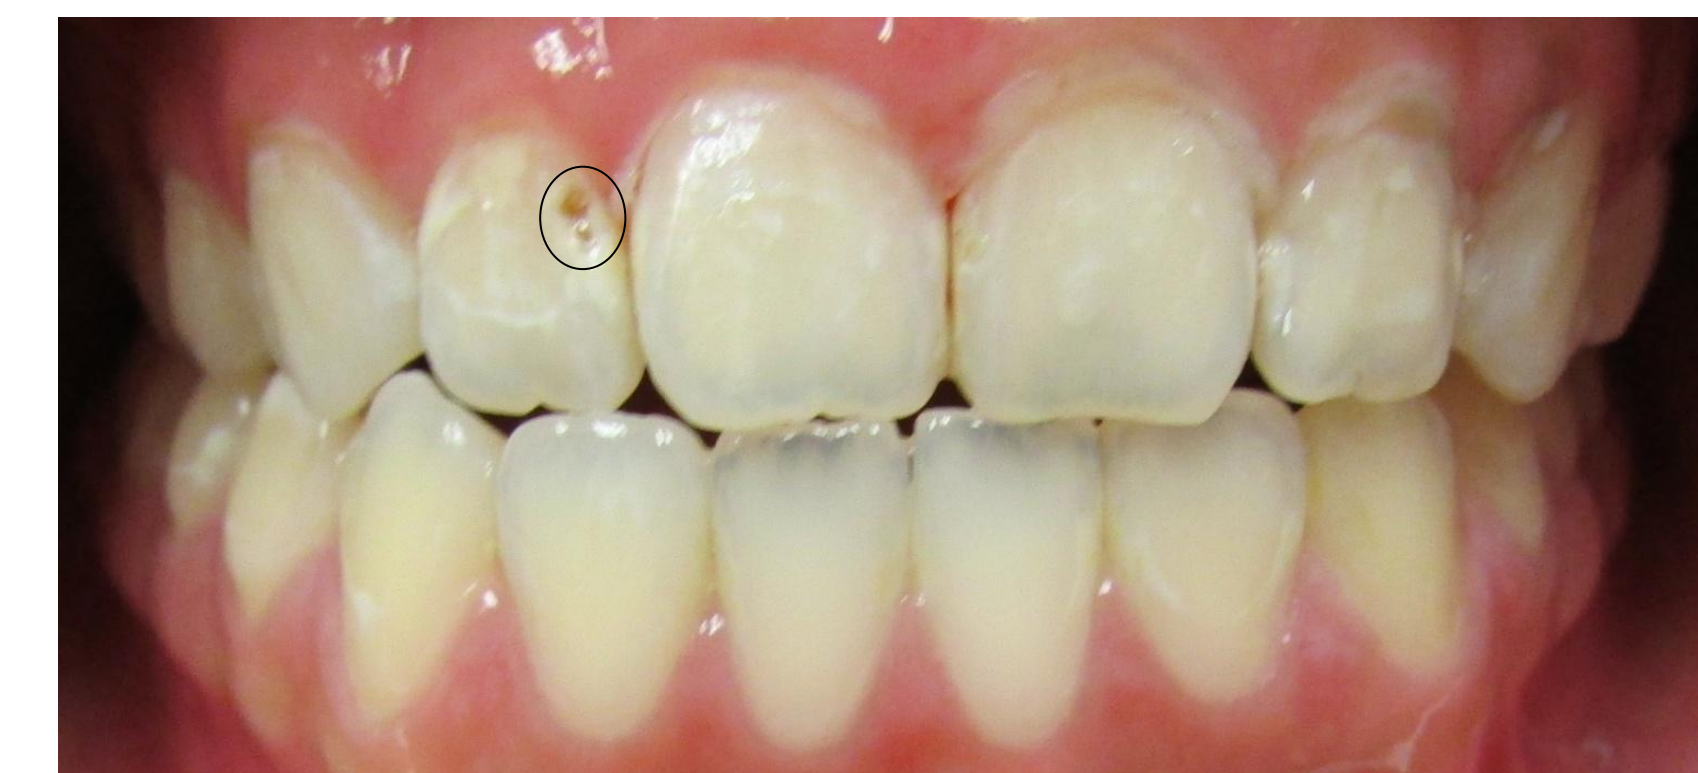
Figure C: Photograph showing maxillary anterior teeth after resin infiltration.

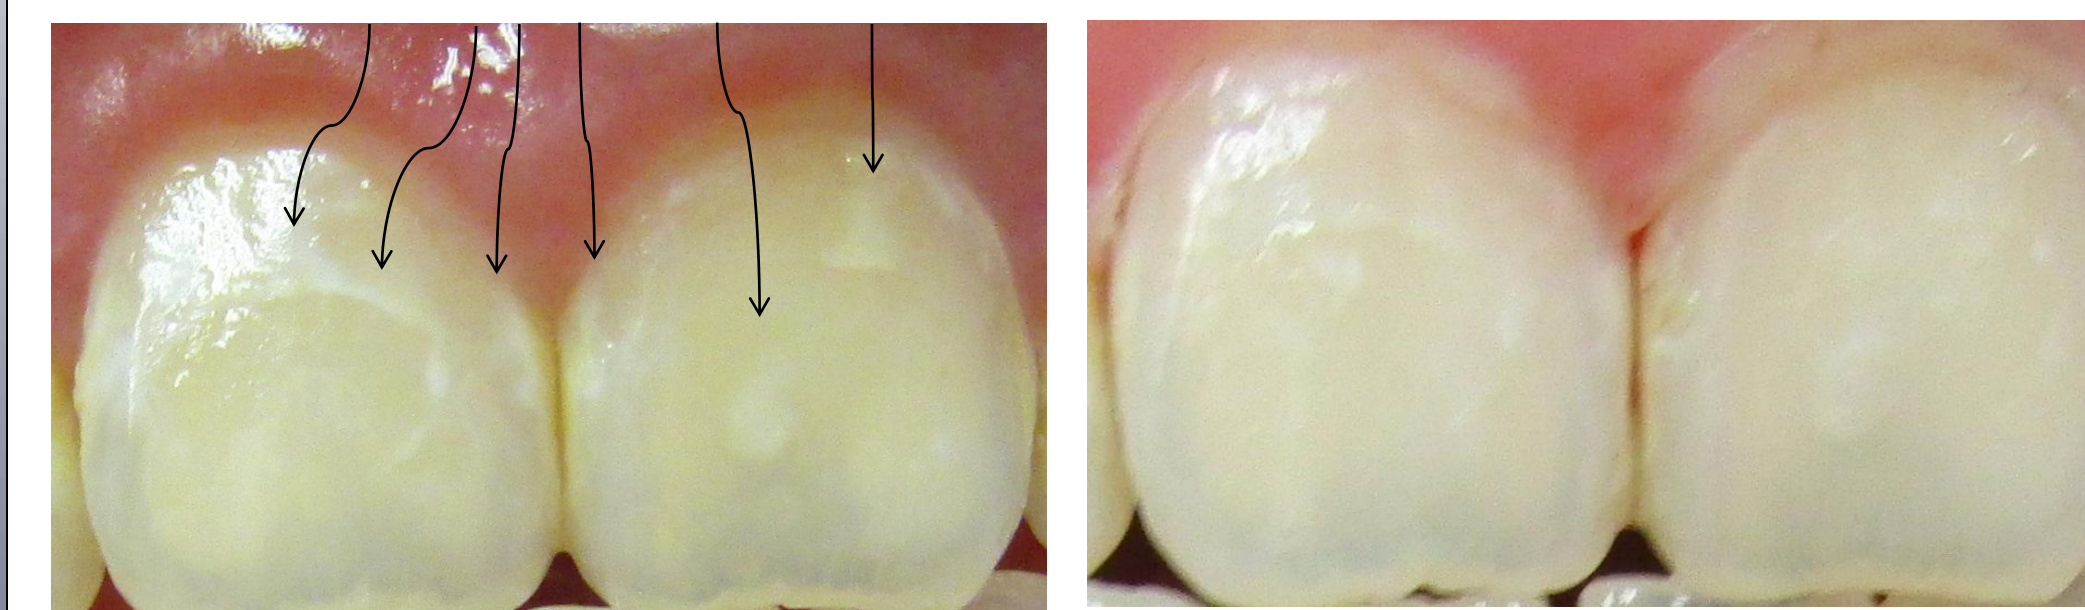
Figure D: Close up of white spot lesions (arrows) on teeth #8 and 9 prior to treatment.

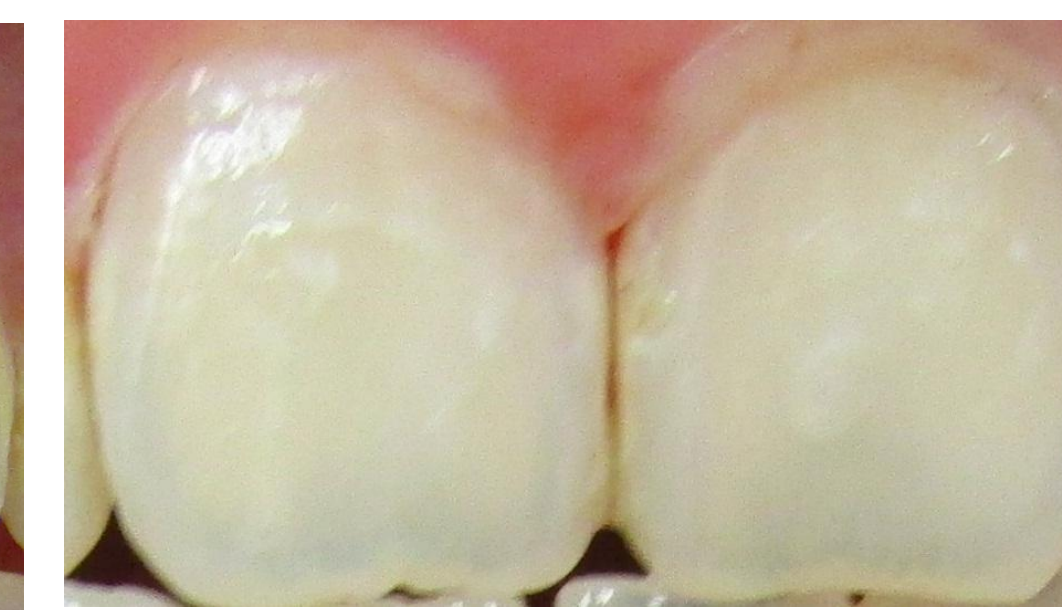
Figure E: Close up of teeth #8 and 9 after resin infiltration.

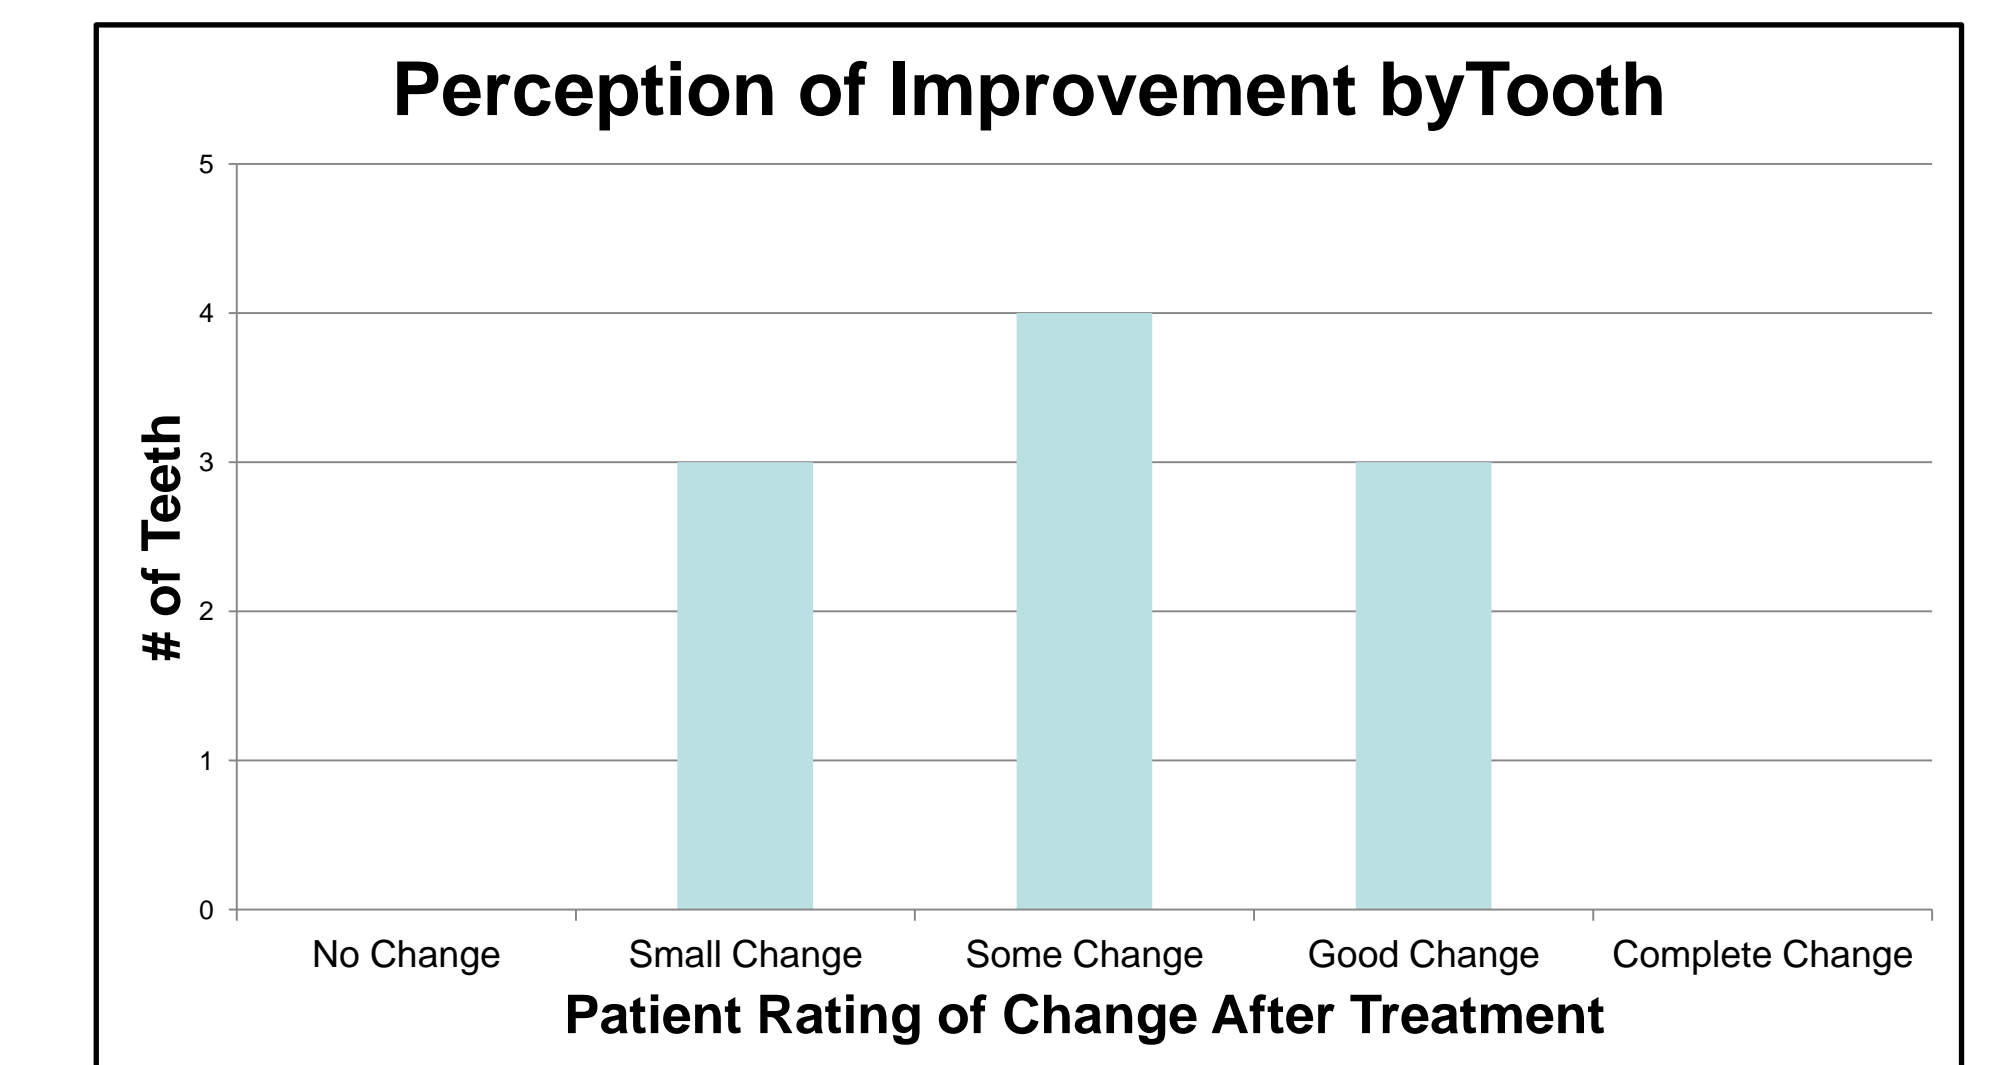
The graph below demonstrates patient perception of improvement immediately following resin infiltration of WSLs, where each individual tooth treated was evaluated.
